# Manhole Inspection Summary

Manhole # S43C\_\_057MH

Insp Date: **7/29/08 9:41 AM**

**Location** Address: **126 N Bonds St**

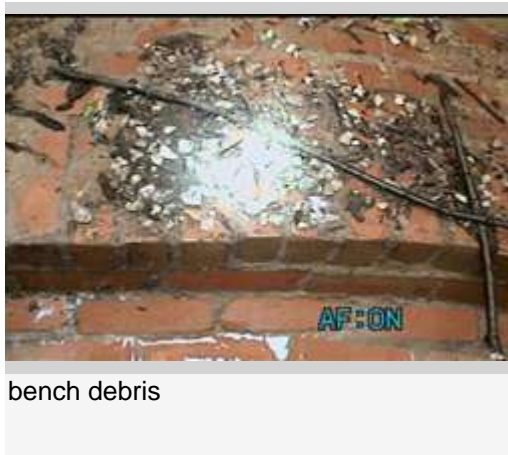
Misc

bench debris

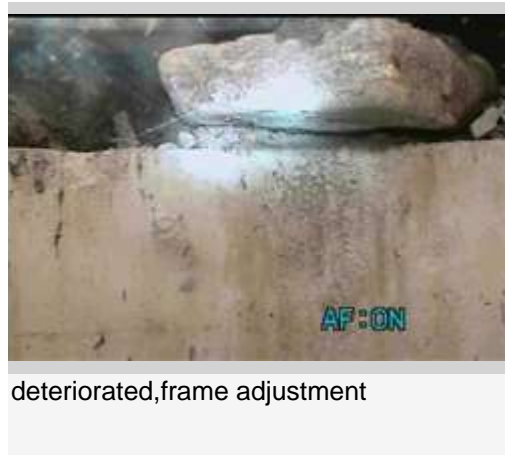
Defect 2

Condition: ☐ Sound ☐ Cracked ☐ Root Intrusion ☒ **Loose Brick** ☐ Deteriorated

deteriorated, frame adjustment

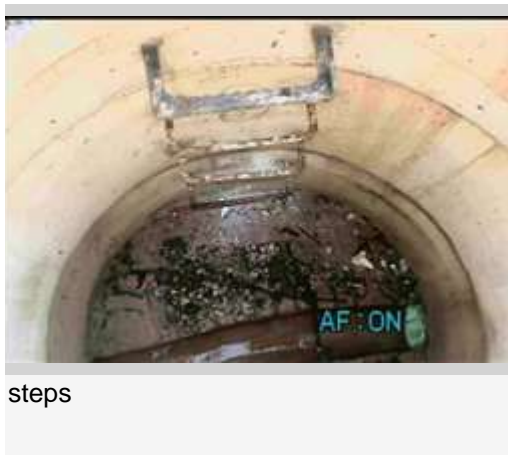
Defect 1

**Steps** Count: **4** Missing: **0** ☒ **Corroded**

steps

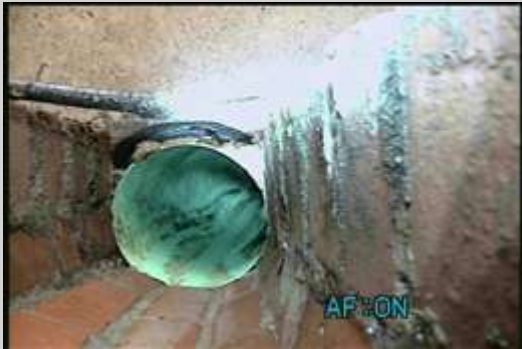
12 O'Clock Outflow

8 in. Circular Gravity Sewer  
Pipe Out @ 12 O'Clock

Pipe Material: PVC ☐ Pipe Lined

Invert Depth: 7.16 (ft.) Flow Characteristics: None

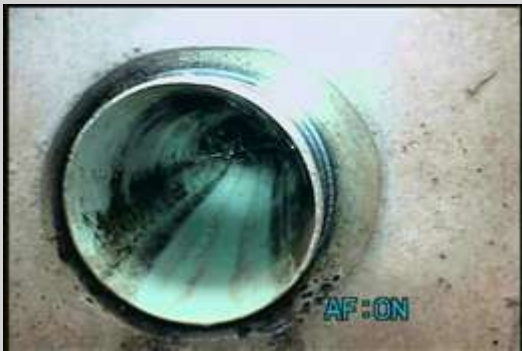
6 O'Clock Inflow

8 in. Circular Gravity Sewer  
Pipe In @ 6 O'Clock

Pipe Material: PVC ☐ Pipe Lined

Invert Depth: 5.80 (ft.) Flow Characteristics: None
